# MEADOWDALE BEACH PARK AND ESTUARY RESTORATION EFFECTIVENESS MONITORING

Year 3 Report

Prepared for  
Snohomish County  
Surface Water Management

July 2026

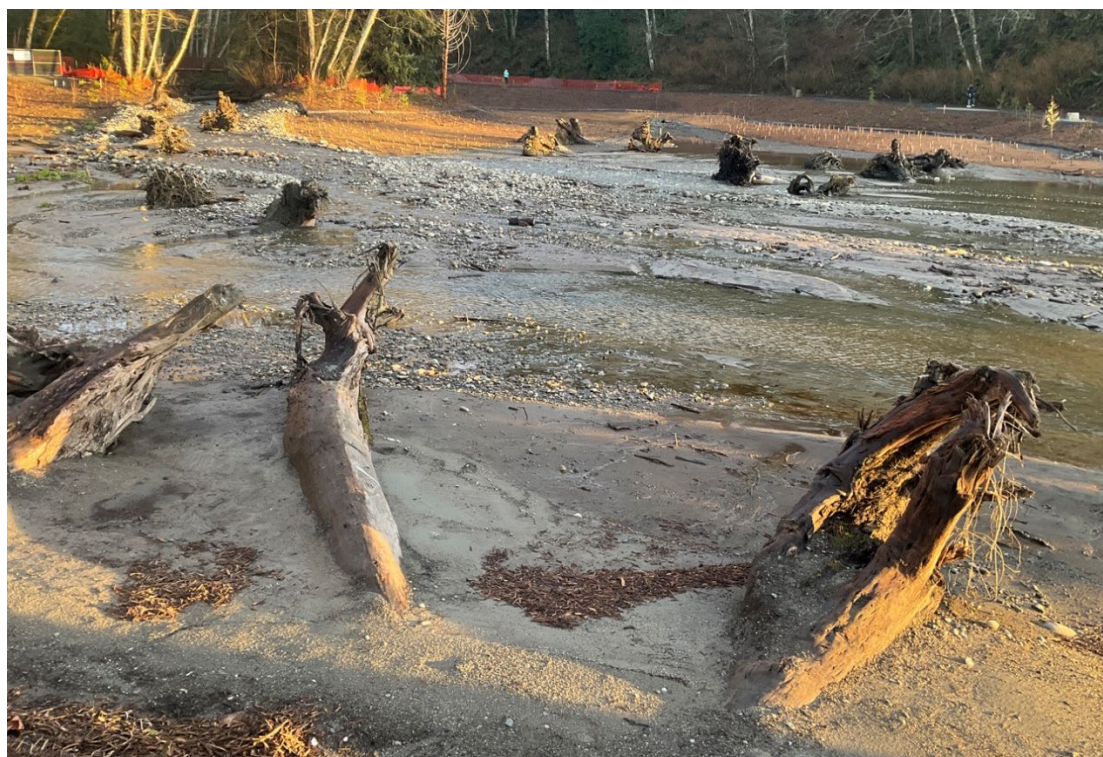
Pre-project monitoring in 2009 and 2021 was implemented in a stream reach with a pool-riffle planform and contained higher amounts of streambank armor (riprap) that covered 28-32% of streambanks as measured between years. This riprap had likely been historically placed to maintain a stream alignment with the railroad culvert and reduce channel migration away from the railroad culvert inlet. As part of restoration, most, but not all, of the riprap was removed upstream from the railroad and the stream channel is now largely unencumbered by this type of modification. In 2023-2025, the quantity of streambank armor as a percentage of the total stream length is much less. New rounded rock streambank armor that was placed at the new pedestrian bridge counts toward total streambank armor as does some remnant locations of riprap. Unstable (eroding) streambanks are only modestly higher overall and primarily associated with one stream location, as discussed as part of the cross section and stream profile changes. **Figure 12** shows the excavated embayment where stream surveys in 2009 and 2021 were located. The excavated and lowered embayment creates a steeper profile between the excavation and the unexcavated creek upstream. This embayment is now transformed, by design, to an alluvial fan planform due to sediment transport from the creek upstream and sediment storage in the embayment.

Lund's Gulch Creek Excavated Embayment Area Looking Upstream Toward the Creek Mouth

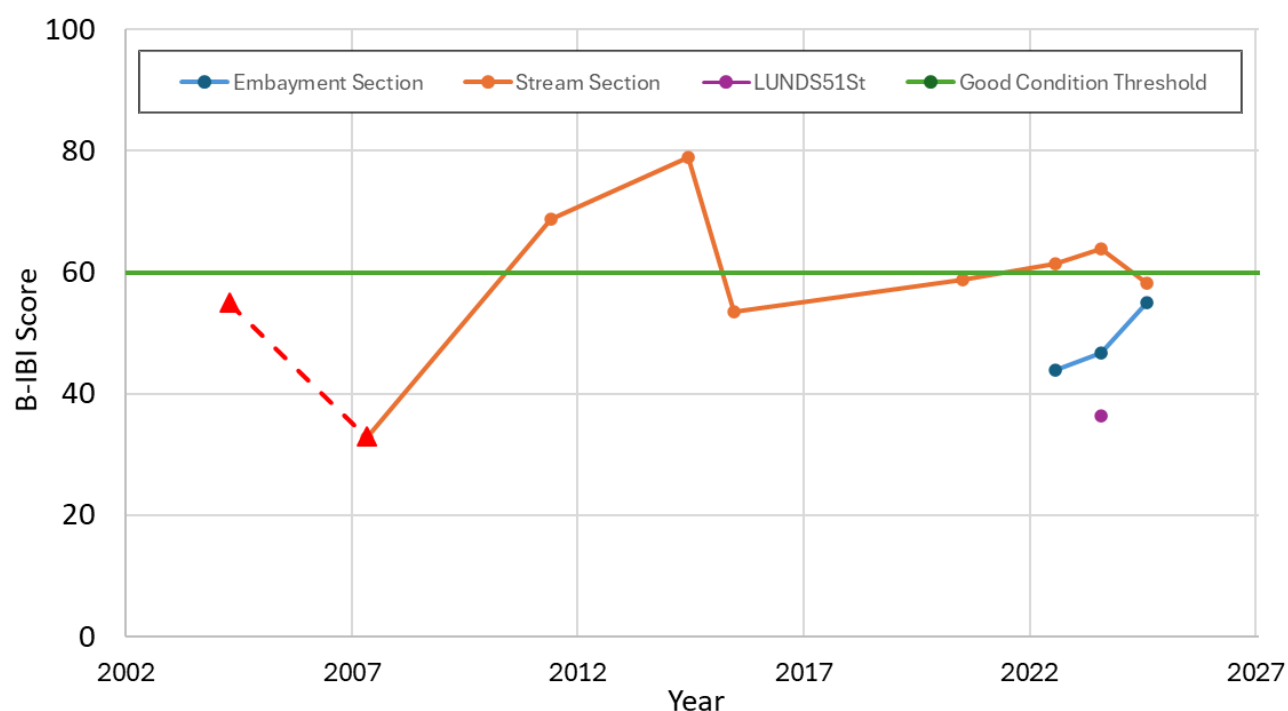
**Figure 13**

B-IBI scores began recovering in lower Lund's Gulch Creek from 2023-2025 (**Figure 13**). The most recent year of monitoring (2025) showed B-IBI results almost identical between the upper- and lower Lund's Gulch Creek reaches. Variation in B-IBI scores between years could be due to natural variation and/or hydrologic conditions such as flooding that disturbed and scoured the streambed in years prior to sampling. Flow conditions that vary annually can also lead to changes in supply and delivery of fine sediment from upstream areas.

Time series of B-IBI scores at Lund's Gulch Creek (2005 through 2025).

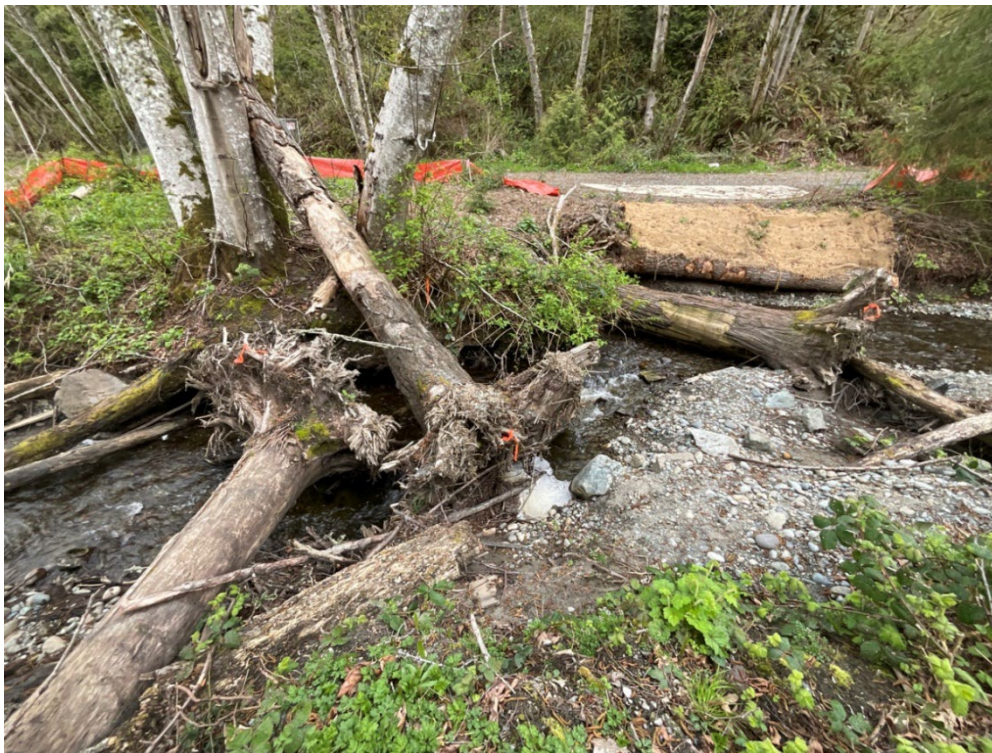
**Figure 16**  
Large Woody Material (flagged) with Rootwads Placed in Lund's Gulch Reach 3
