# MEADOWDALE BEACH PARK AND ESTUARY RESTORATION EFFECTIVENESS MONITORING

Year 3 Report

Prepared for  
Snohomish County  
Surface Water Management

July 2026

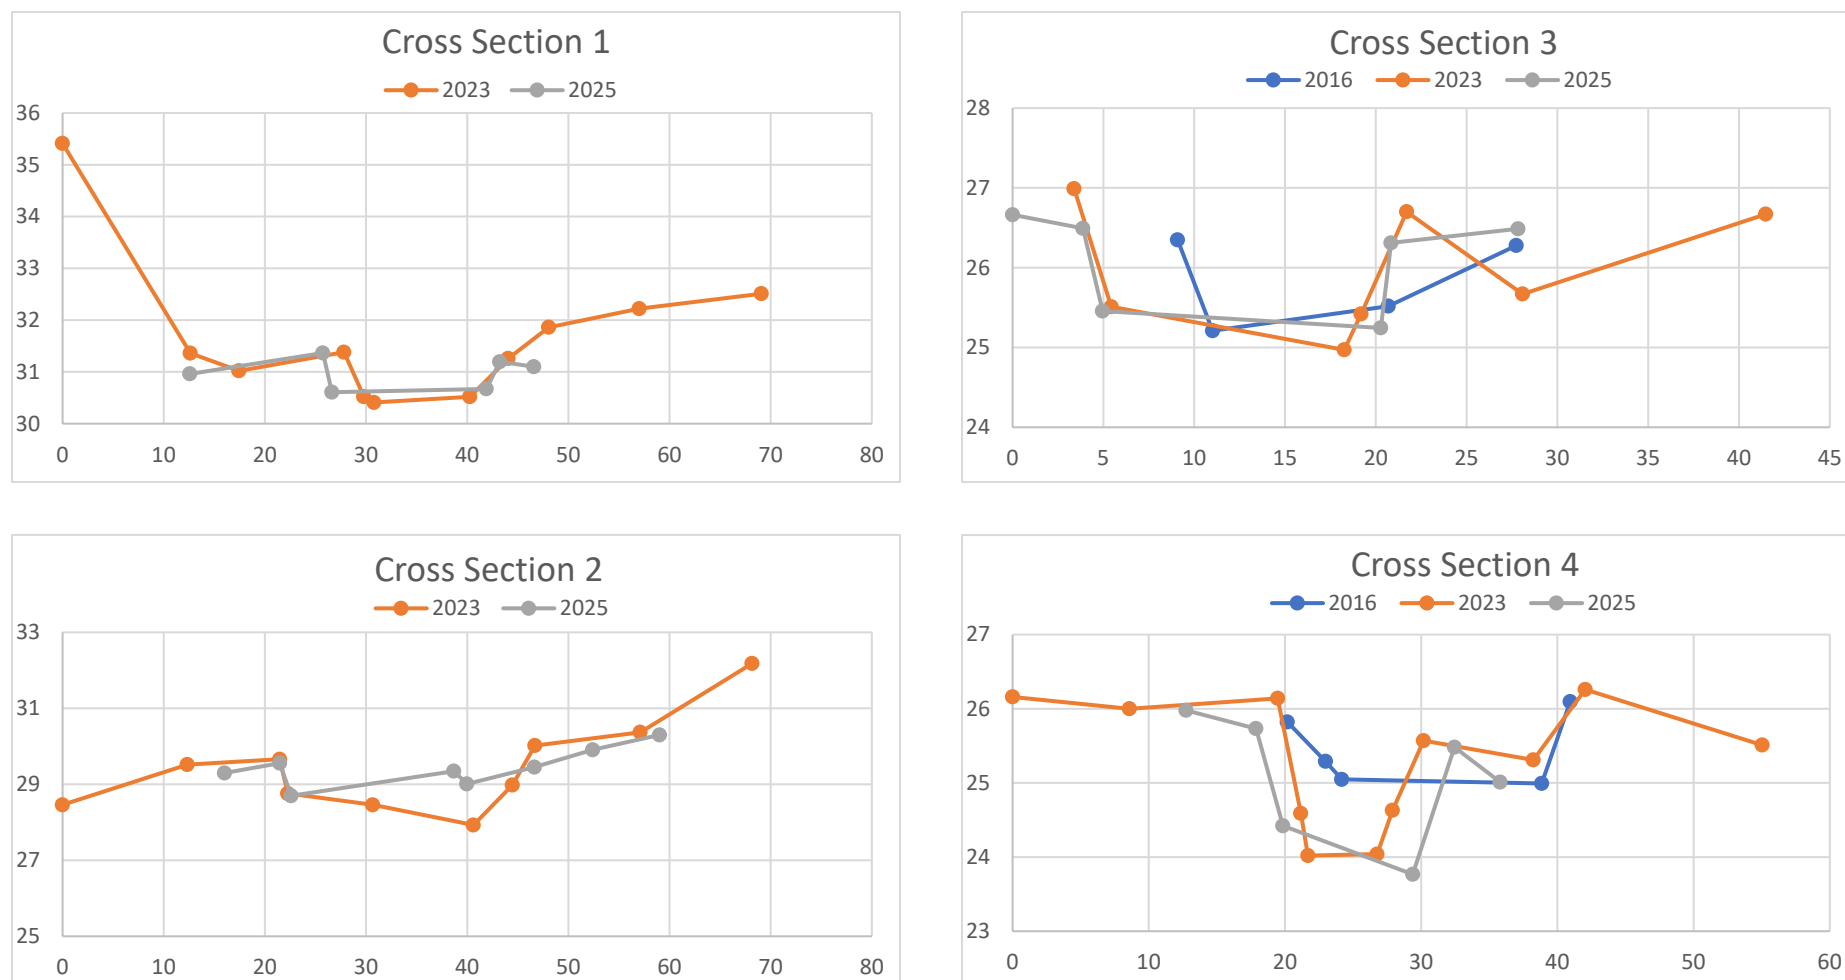
**Figure 5**  
Cross Section Series 1-4

Cross sections 1-3 (**Figure 5**), in the upper part of the stream, do not show much variation in the elevation of the channel over time. These locations are upstream from a distance of approximately 1,200 feet (on the x-axis in **Figure 9**) shown on the longitudinal profiles which also show limited variability in channel elevation over time in the upper creek. This indicates that little channel change or adjustment has occurred over time or since placement of large woody debris as part of stream restoration. Cross sections 4-7 (**Figures 5 and 6**) show more interannual variability in the streambed elevation among years and are generally lower in elevation than observed in 2016. This indicates that there is greater fluctuation in channel elevation or gravel deposition along the channel distance (profile) spanned by these cross sections. Additionally, field observations included notable channel incision downstream from the new pedestrian bridge (Cross-section 7; **Figure 6**) and at other locations where the streambed has decreased in elevation – either exposing previously buried woody debris or leaving some newly placed woody debris at higher elevations and less functional relative to the adjusted streambed elevation today. This decrease in streambed elevation is most notable in the stream longitudinal profiles (2016-2025) between distance 900-1150 feet (**Figure 9**), where the streambed elevation is lower than in pre-project years (2016, 2021), though no embayment excavation was present in this part of the project. Cross-sections 9-13 (**Figure 7**) between longitudinal profile distances 600-900 feet (**Figure 9**) overlap with the embayment excavation which is revealed in these cross-section elevation differences between 2016 and 2023/2025. These cross-sections and profile elevations show more subtle changes between 2023 and 2025 post-excavation, though fewer profile points from 2023 make direct comparisons to 2025 changes in the profile more uncertain.

- There is little channel change in the upstream part of Lund's Gulch Creek near the Ranger bridge.
- There is channel lowering in the vicinity of the new pedestrian bridge which can undermine streambank stability and lead to more erosion and an imbalance in channel slope from upstream to downstream of the pedestrian bridge.
- There is sediment aggradation as well as expected channel switching on the alluvial fan that is growing in the excavated embayment (an effective sediment sink); and,
- There is downstream sediment deposition beachward of the BNSF railroad bridge relative to as-built elevations that is likely controlled by tidal backwatering and limits transport of sediment out of the embayment.

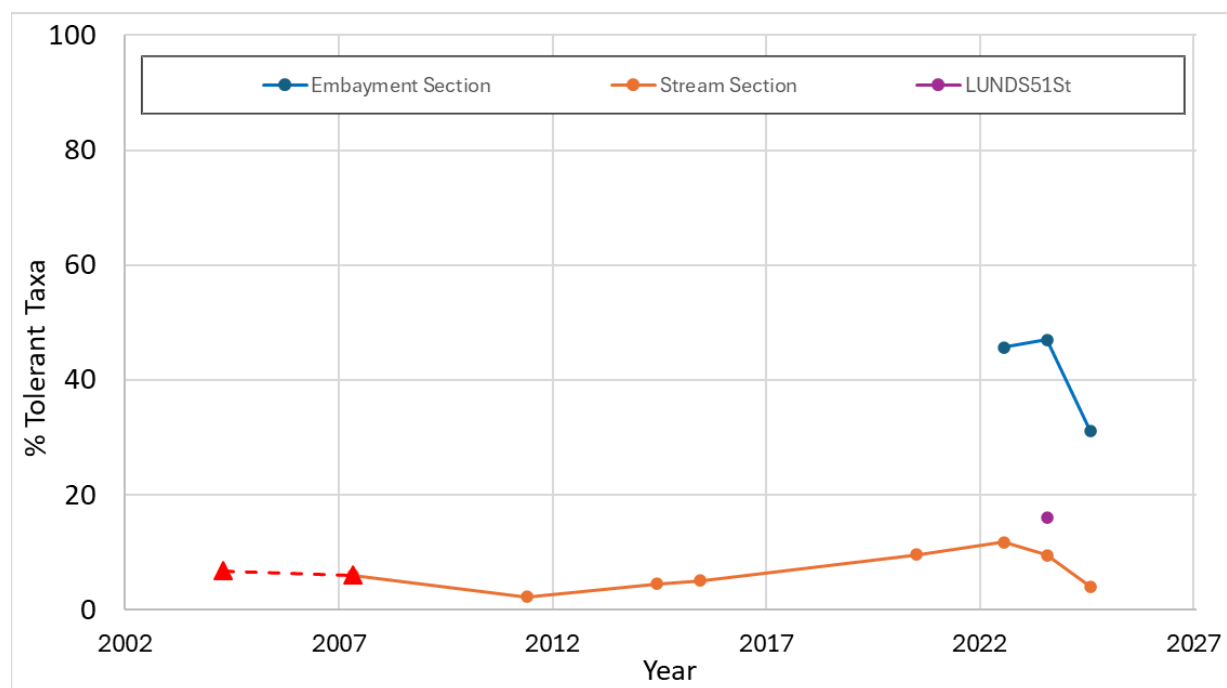
**Figure 14**

There was a dramatic increase in pollution tolerant taxa as a characteristic of the benthic invertebrate community in the lower Lund's Gulch Creek reach following construction (**Figure 14**). Signs of physical habitat and food base disturbance are associated with appearance of species tolerant to disturbance or pollution. Expectations for community recovery in the lower Lund's Gulch Creek reach would resemble the range of past conditions and current conditions in the upper Lund's Gulch Creek reach.
