Environmental Education, Assessment, & Management

Value, Benefits and Limitations of Vegetation in Reducing Erosion

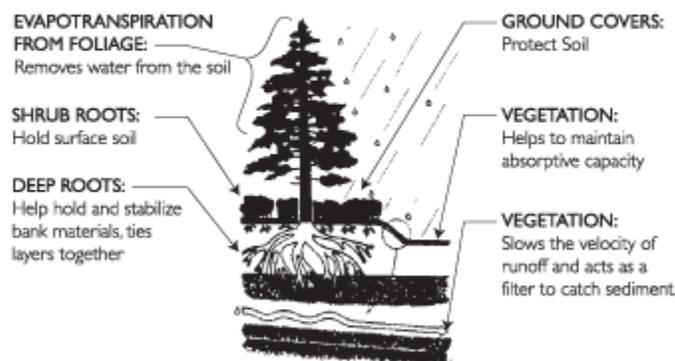
1. Foliage intercepts rainfall, causing absorptive and evaporative losses that reduce surface water runoff and erosion.
2. Evergreen trees and shrubs continue the metabolic activity known as evapo-transpiration, which extracts moisture from the soil, throughout the year. As logging or clearing occurs, water table levels rise, and soils remain saturated for longer periods, reducing soil cohesion and increasing the rate of land slides.
3. Roots reinforce the soil, increasing lateral soil shear strength and cohesion during saturated conditions. Many slopes can persist beyond their angle of repose and remain stable as a result of the complex root networks within soil blocks.
4. Tree roots anchor soil strata vertically and laterally by means of large-diameter structural roots. These roots may extend well beyond the tree's canopy or crown.

FIGURE 1. ROLE OF VEGETATION IN REDUCING EROSION AND STABILIZING SLOPES. (MENASHE, 1993)

5. Roots, especially the fine feeder roots of trees, shrubs and groundcovers, bind soil particles at the ground surface, reducing their susceptibility to surface erosion and slumpage during saturated soil conditions.
6. Large trees can arrest, retard, or reduce the severity and extent of failures by buttressing a slope. This works in much the same way as retaining walls. In the case of trees, though, the system is to some extent self-repairing, and it becomes progressively stronger over time, whereas engineering structures are strongest when installed and become progressively weaker over time. Obviously, planted trees need adequate time to develop root systems and become effective in stabilizing slopes.

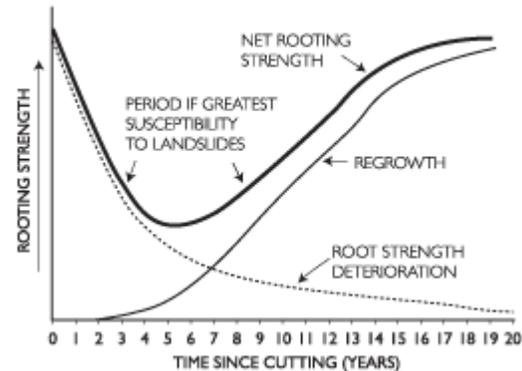
FIGURE 2. CONCEPTUAL GRAPH INDICATING ROOT STRENGTH DETERIORATION AFTER CUTTING (R. SIDLE, 1984)

The limitations of vegetation in preventing, reducing or arresting slope failures and erosion is often due to previous land management practices such as logging, topographic alterations, increased or channelized surface water flow, and wholesale clearing. Once initiated, slope failures require an expenditure of time, effort, critical planning and money to stabilize them successfully. The use of vegetation in particular requires foresight and several years of monitoring and maintenance until plants are established and effective. Establishment can take up to three years. It can take up to 15 years for shrubby vegetation to develop the values discussed above, even longer for trees to reach sufficient stature to be effective. The impacts of tree cutting on steep slopes can take several years to become apparent, as illustrated in figure 2.

should be well established (2-3 years) before alders are removed, in order to maintain adequate soil-binding benefits within the effective root zone (ERZ) of the cut trees. The ERZ can be approximated as a one-foot radius of lateral root extent for every inch of diameter of the tree's trunk. Preparatory to planting, alders (as well as cherry) can be thinned to a spacing that will not compromise slope integrity during the establishment period. Tree cutting on slopes without replanting can have serious future consequences as illustrated in figure 2.
